## Trenchess Technology,

## **History Preserved in Turkey**

Pipe Relining Rehabs Ancient Sewer Pipes

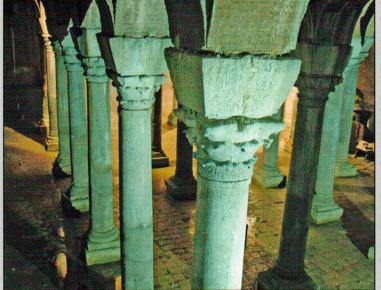
A leaky sewer pipe above the Binbirderek Cistern was cause for concern.

An excellent example of the kind of dilemma regularly faced by ISKI is the Binbirdirek Cistern, which was built in AD 330 as Constantinople was being founded. As centuries passed, the infrastructure above this 224-column cistern grew and changed. Today, restaurants and hotels line a cobblestone street above the cistern; inconveniently, the sewer pipe servicing this street began leaking and

exfiltrating into the cistern below. To exhume and replace the old sewer line would close businesses, disrupt traffic in the heart of the historical tourism district and most probably destroy the cistern below. To do nothing would be to allow the continued decay and disuse of the cistern.

The sewer pipes above the cistern were lined at night to prevent disrupting the nearby Magnaura historic site and the numerous hotels, restaurants, shops and tourist traffic. With the pipe ends accessible through the manholes, no excavation was required and no evidence was left of the project upon completion. The next morning, the cafés all
